TSB-OT-0014

Date: November 01, 2021

Subject: Ductless 17 Series, 18,000 BTU Heat Pump – Potential EEV Malfunction

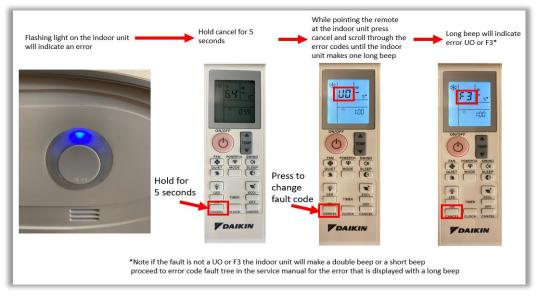
Repair is only needed for product not cooling and displaying "F3" and "U0" error codes. Daikin recommends using test procedure elaborated below to compare the resistance values of the EEV to the specifications. If the resistance values are outside specification, replace the EEV. If the PCB has malfunctioned due to the EEV failure, both will require replacement.

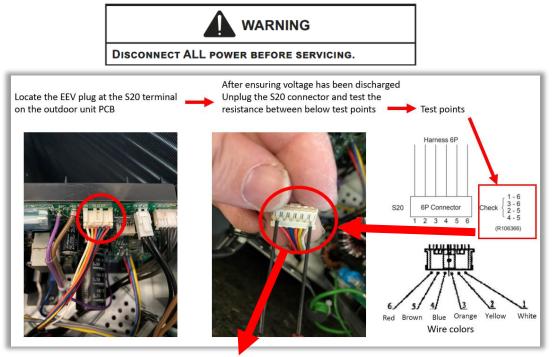
Resistance values at the test points should read about 45 Ohms If the resistance value is open or too low (shorted) the coil has failed and will need to be replaced

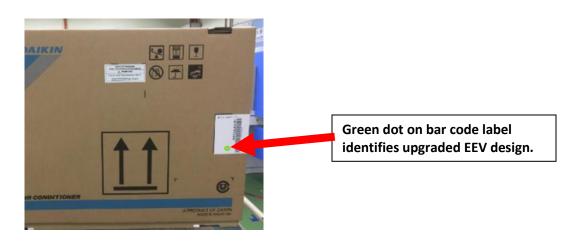
The EEV coil design has been improved for 17 Series, 18,000 BTU heat pumps (Model Number: RXB18AXVJU). A new EEV design has already been implemented for all shipments starting August 1, 2021. There are no model number changes. Updated equipment can be identified by a green dot on the bar code label.
